BS EN 13823:2010+A1:2014

**Reaction to Fire Tests for Building Products -
Building Products Excluding Floorings Exposed to
the Thermal Attack by a Single Burning Item**

A Report To: Smarter Surfaces Ltd

Document Reference: 370215

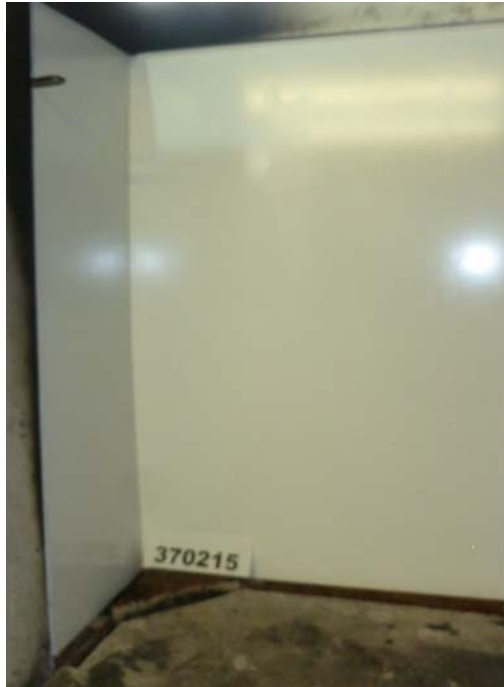
Plate 1: Total View of the exposed surface of the long wing.

Photographs of the installed product are appended as Plates 1 and 2 in Appendix 1 of this report.

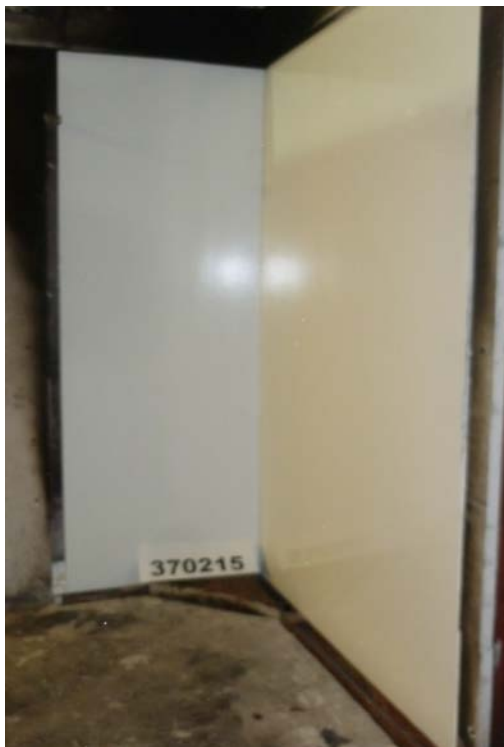
Plate 2: Close up view of the vertical outer edge of the long wing at a height of 500mm
